**HALL FARMHOUSE
THORNTON LE DALE
HERITAGE STATEMENT
November 2025**

1. EXECUTIVE SUMMARY

| Site Name: | Hall Farmhouse |
| Address: | Maltongate, Thornton le Dale, Pickering, YO18 7SA |

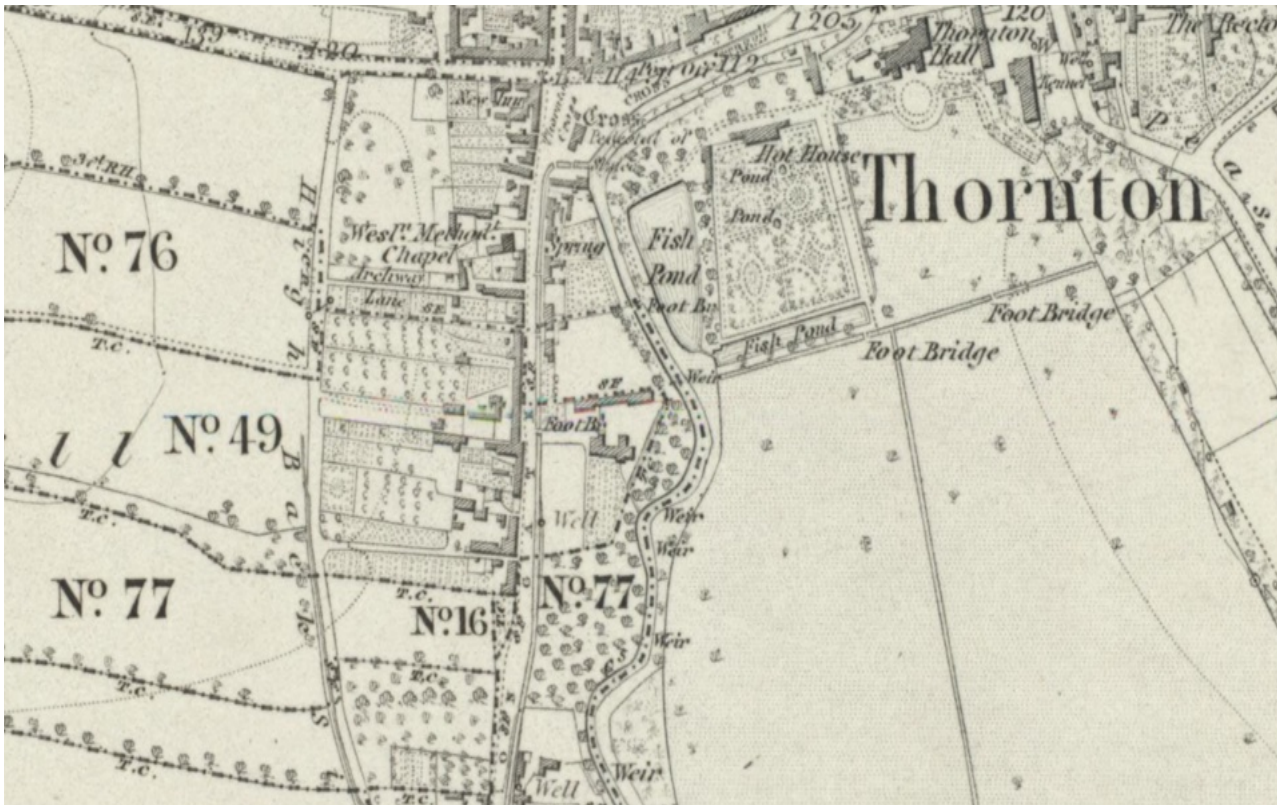
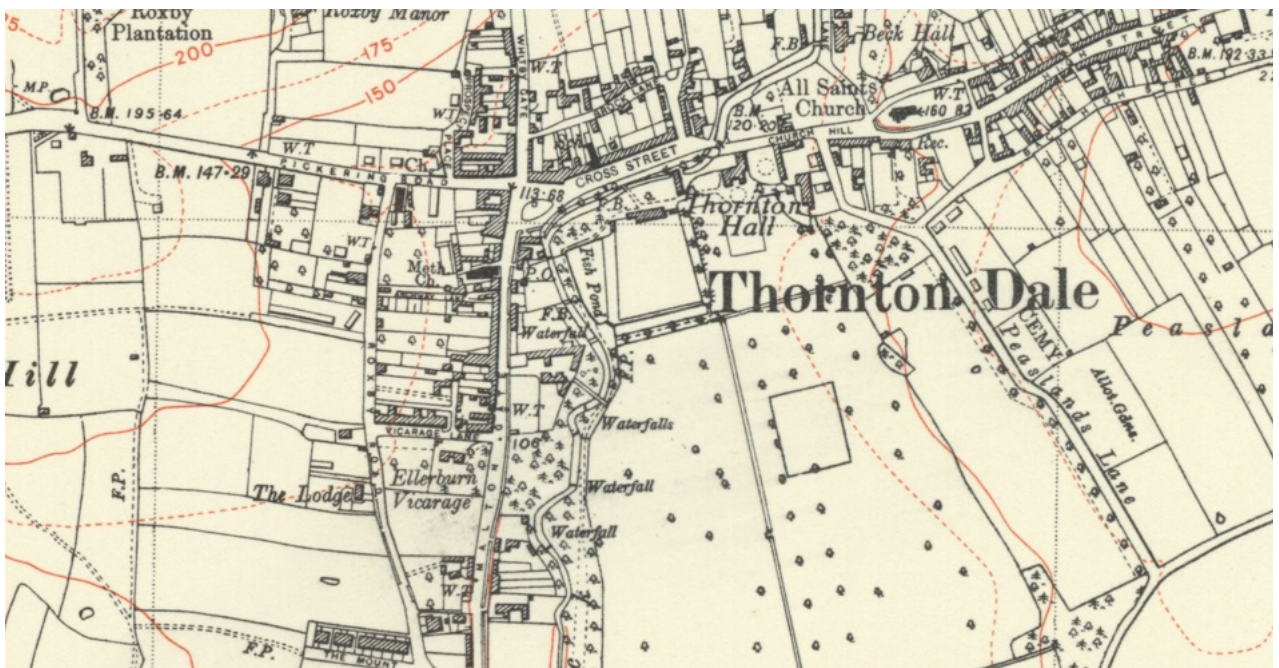
Figure 5, Ordnance Survey Map – Surveyed 1848-50 (6 inch).

Figure 6, Ordnance Survey Map – Surveyed 1890 (6 inch)

Figure 7, Ordnance Survey Map – Revised 1926 (6 inch)

Figure 8, Ordnance Survey Map – Revised 1950 (6 inch)

Cartographic evidence indicates that the farmyard became a roofed structure between 1890 and 1926, most likely associated with dairy operations. This covering had been removed by the time of the 1950 Ordnance Survey.

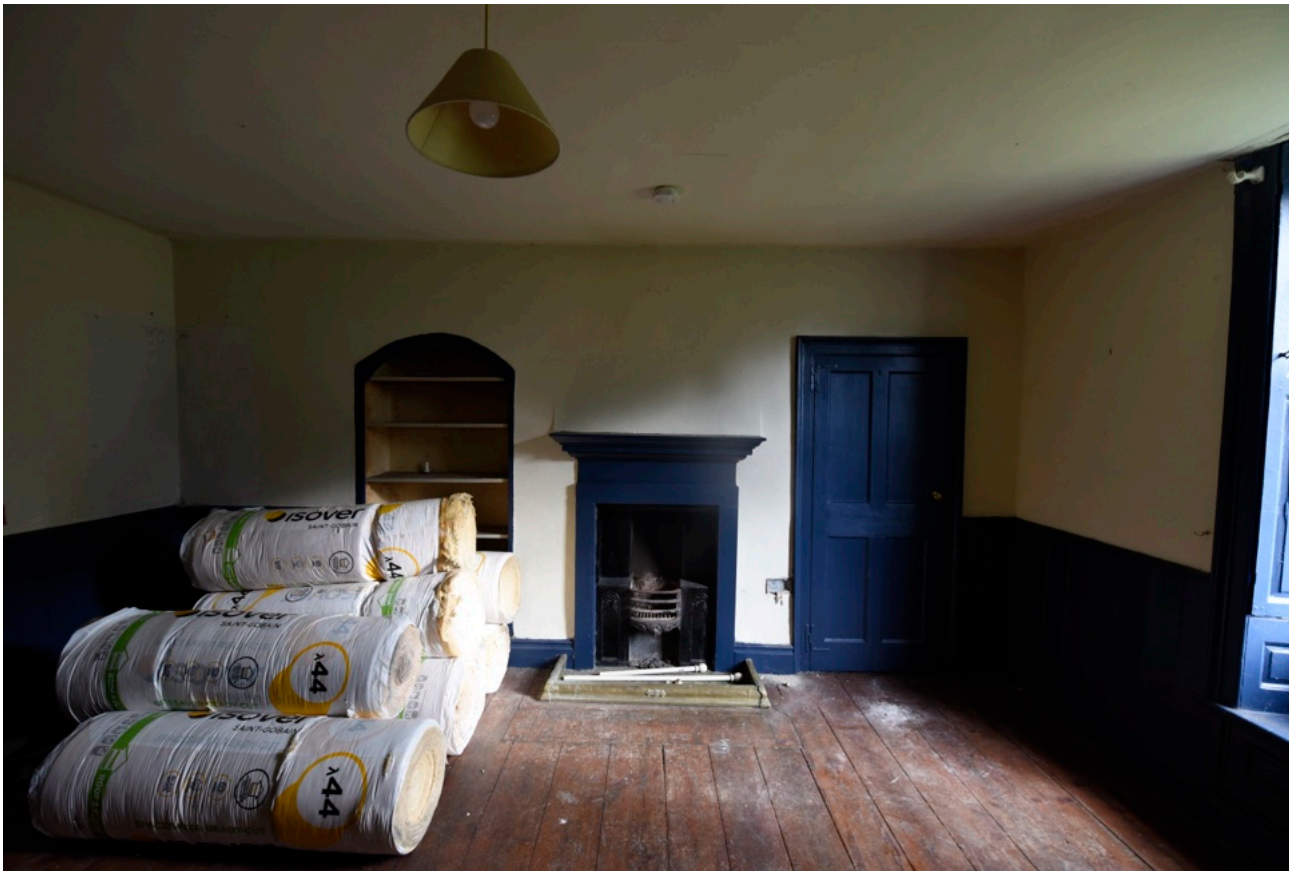
Figure 10 Original Drawing Room

The drawing room-traditionally associated with the lady of the house and intentionally separated from the historic service areas-retains its original fireplace with surround and Pantheon grate. The window shutters have raised and fielded panelling, folding into the reveals on butterfly hinges - already becoming unfashionable by 1815–1820. The ironmongery in this room and elsewhere includes locally forged L-hinges, H-hinges and unornamented strap hinges, all consistent with late-18th-century estate work. A number of doors show re-use: some have the “outer” face hung inward, others combine mismatched hinge types from earlier buildings. The matchboarding forms part of the 1920s alterations, most likely introduced to conceal rising damp within the wall fabric. The floorboards are noticeably wider than those found elsewhere in the house, indicating a higher-quality and more costly material. The comparatively low ceiling conceals the principal beam and joists above, reflecting contemporary expectations and finishes of the period.

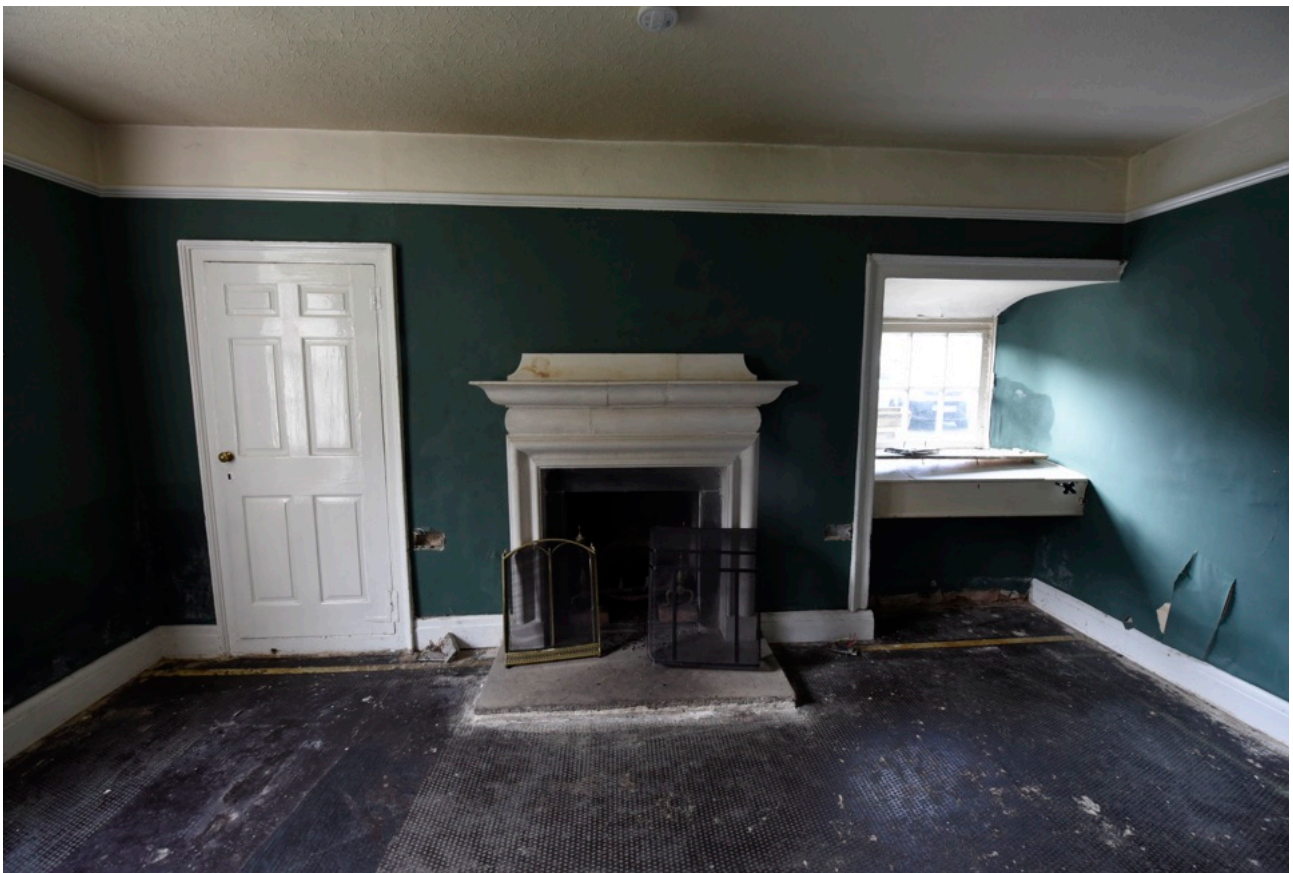
Figure 11. Original Dining Room

The dining room retains its principal ceiling beam, now plastered and papered, and incorporates modern skirting boards and picture rails. The four-panel door from the hall matches that of the drawing room, and the associated door and window surrounds share the same flat-section profile. Beside the fireplace, the built-in cupboard features a six-panel raised-panel door hung on mixed hinges (one L-hinge and one H-hinge), consistent with the estate's historic reuse of serviceable joinery.

The front window mirrors the drawing room arrangement, with equal lights, shutters and a window seat, although the shutters were not originally made for this opening and a central strip has been inserted to close the gap. The fixed side window has a deep sill with a shallow storage space beneath but no seat. Evidence of rising damp is visible on the wall surfaces.

The fireplace is the most architecturally refined in the house. Its surround appears original and is well aligned with the expected design of the period.

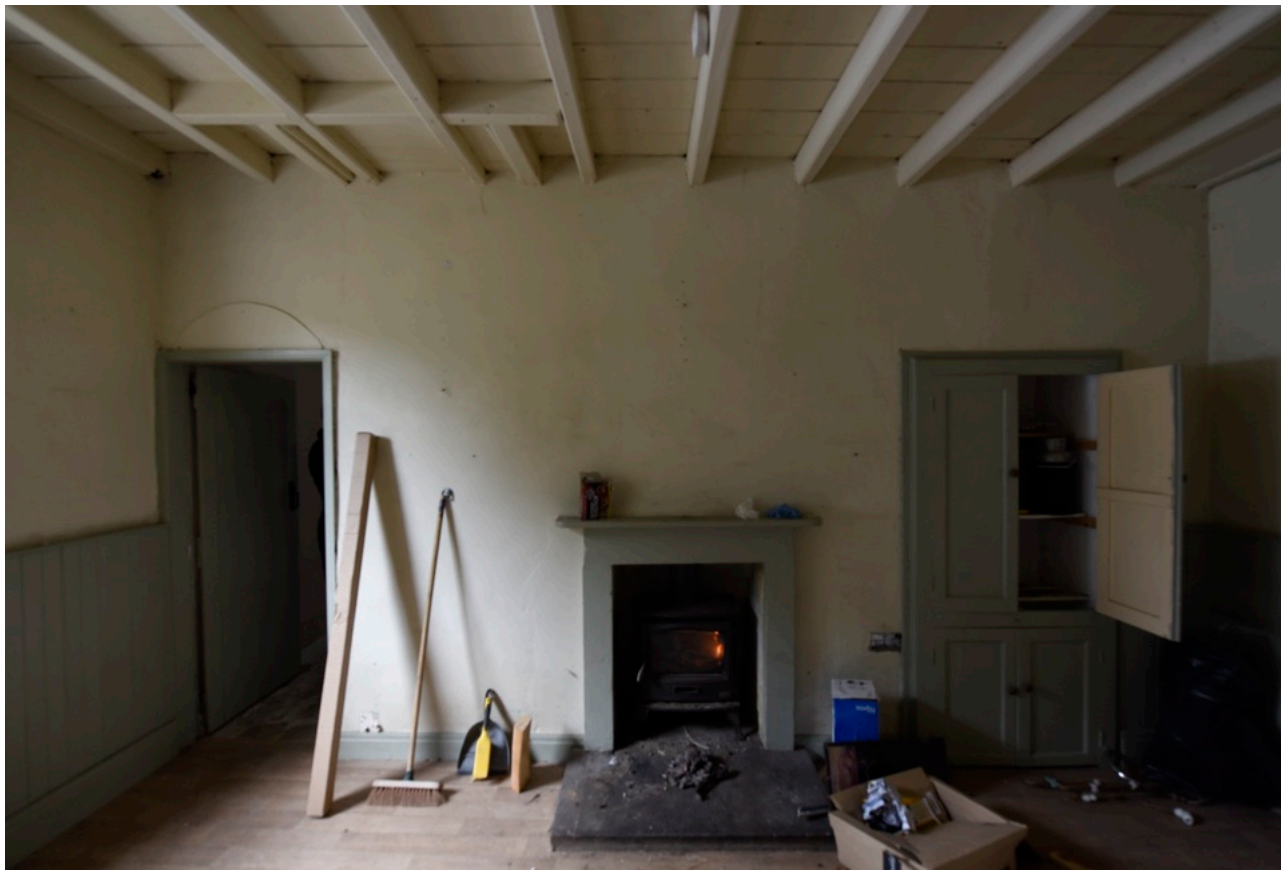
The kitchen originally occupied the rear central position and retains evidence of a former range on the north wall, as well as an early cupboard with blacksmith made spade-end strap hinges. A sash window includes the remnants of a blind mechanism. Adjacent to the kitchen was a large service room, almost identical in size, with its own fireplace, external door, Yorkshire sash to the north and a small corner cupboard near the hearth likely used for salt or herbs.

Figure 12: Kitchen, with smaller fireplace replacing range, original cupboard to the right

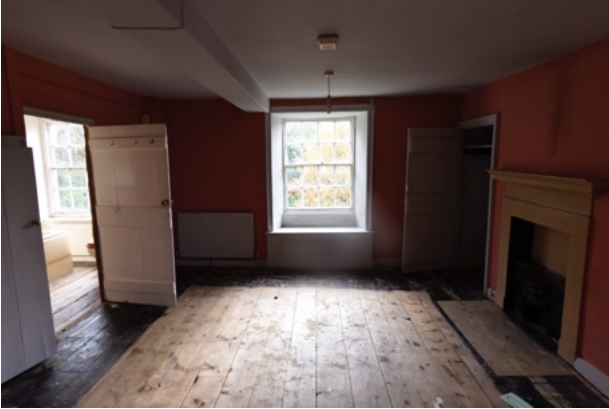
Bedroom 1 – Fireplace, 8 over 8 sash window

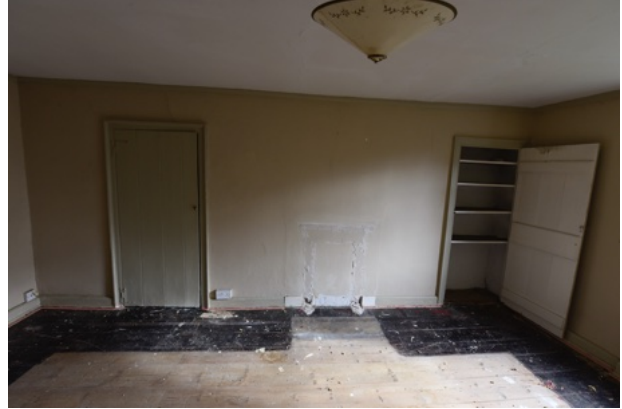
Bedroom 2 – Showing site of original fireplace.

Recent changes include refitting the kitchen with modern units and finishes while retaining older fixtures such as the corner cupboard and plank doors. Bedrooms have been fitted with en-suite bathrooms, not sympathetically done and of poor quality, likely corresponding to use for bed-and-breakfast accommodation. This resulted in the removal of fireplaces in some rooms (e.g., Bedroom 2).

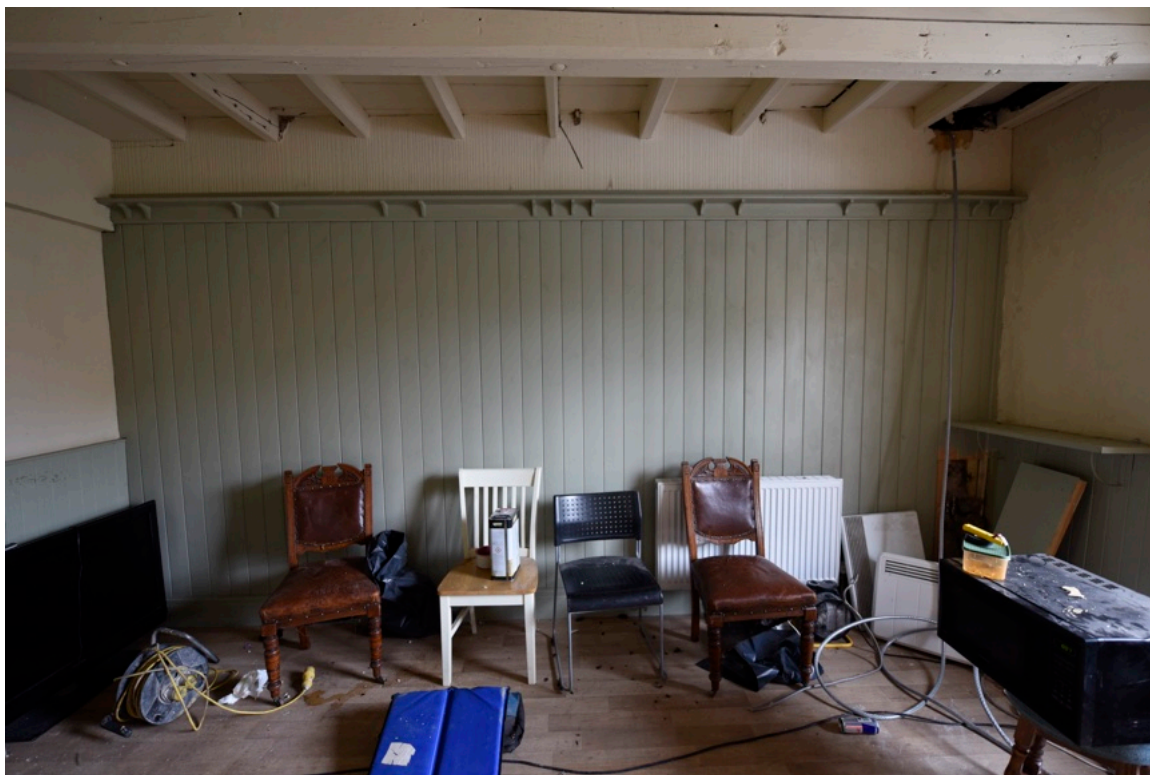
Inter-war alterations were extensive. A timber partition was erected in the kitchen to create a corridor, featuring a plate-display shelf characteristic of 1920s fashion. The old range was removed and replaced with a smaller fireplace. The former scullery and dairy were opened out to form the working kitchen, floored with quarry tiles.

Figure 15 1920s Timber Partition with plate-display shelf (top) in kitchen.

| Proposed Work | Comment | Impact | Assessment of Harm |
|--|--|---|--|
| Timber boarding screen to be removed and replaced with timber stud partition. | Removal of 20th century addition. | Neutral | Less than substantial harm |
